PAPER NO: TP10-19

COOLING TECHNOLOGY INSTITUTE

A SYSTEMATIC APPROACH TO PERFORMING, DOCUMENTING AND REPORTING INSPECTIONS OF FIELD ERECTED COOLING TOWERS

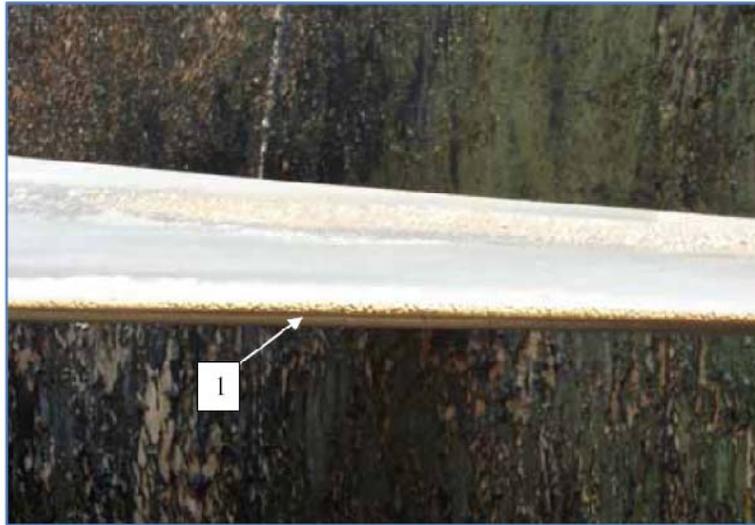
Figure 14: Fan Blade- The fan blades were found with a considerable amount of wear and pitting in the fiberglass. Detail point one refers to pitting on the leading edge of the fan blade that is caused by water droplets invading the plenum.

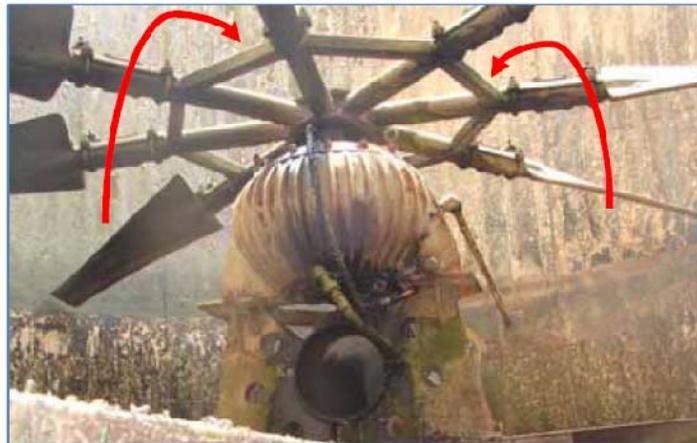
Figure 15: Fan Assembly- The fan assembly in the west cell is missing the FRP disk seal. The red arrows display the vacuum that is created at the fan hub causing air to re-circulate the fan assembly.
